Negative impressions of the rope's surface in the grooves of sheaves and drums

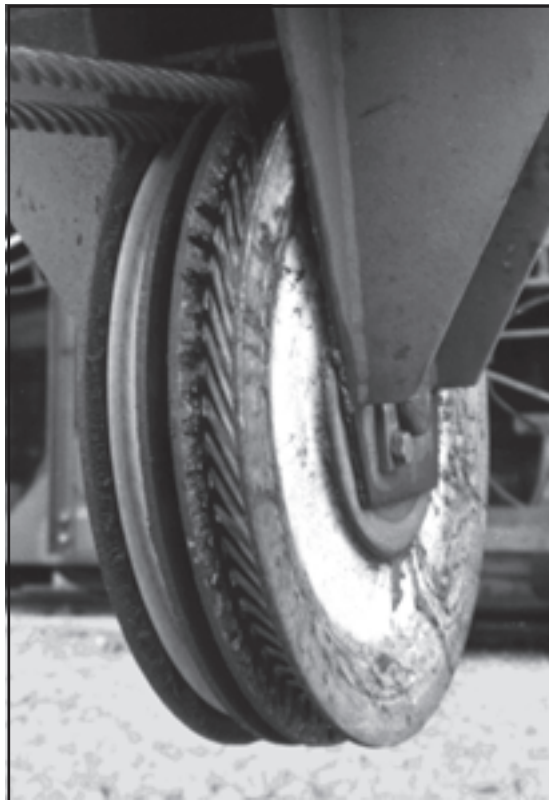
Quite regularly on cranes and other rope drives impressions in the grooves of the sheaves or drums can be found which look like the negative imprint of the wire rope in use (Fig. 1). The reasons for the occurrence of such damage have not been fully cleared up yet. This treatise investigates the phenomenon.

Figure 1: Wire rope sheave with negative impressions

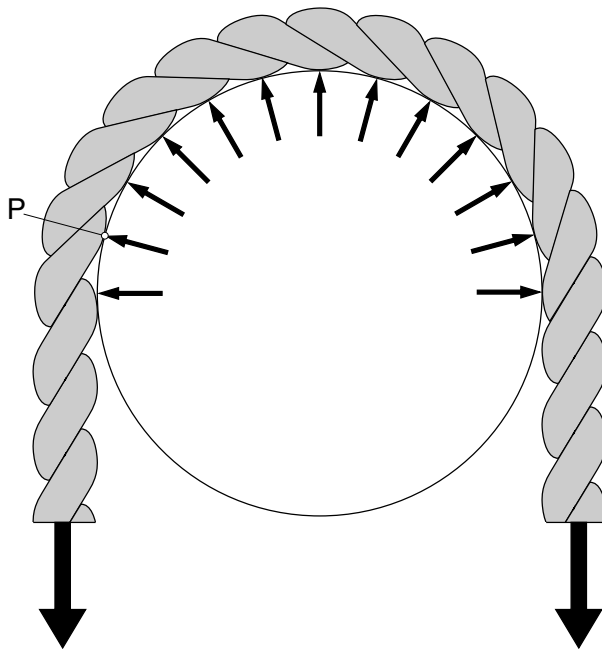
A wire rope rests on a sheave with the crowns of its outer strands at a limited number of contact points (Fig. 2). As in these few points the reaction forces

to the line pull of the wire rope are transmitted, quite often relatively high pressure forces between the wire rope and the sheave occur in these points. These high pressure forces in combination with tiny relative motions between the wire rope and the sheave when the wire rope is spooled on and off are responsible for the material abrasion on the sheave and rope surface. Under normal circumstances this abrasion will be distributed very evenly along the circumference of the sheave. It requires very special conditions for a negative impression of a wire rope to occur on a sheave or drum.

Figure 2: Contact conditions

crown lies at the beginning of the operation cycle (Fig.2).

At the beginning of the operation cycle a strand crown rests on the groove in point P (Fig.2). If the sheave carries out a small angle of rotation, the strand crown lying in point P will leave the bottom of the groove. After a rotation of 180° the wire rope will come to lie again in the neighbourhood of point P with a different strand crown. It is likely that the strand crown will not exactly hit point P but, for example, a point 1mm away from point P. After one more rotation of 360° the new point of contact will have moved away from point P by another millimeter. In this way it is guaranteed that for spooling of a greater rope length the contact points of the strand crowns are evenly distributed on the sheave's surface, so that the unavoidable material abrasion is evenly distributed along the circumference of the sheave.

A wire rope which has dug its own profile into the bottom of a groove will find relatively favourable bearing conditions. While initially every strand crown only had point contact with the groove (Fig. 2), it is now supported by a greater area (Fig. 6). As a result of the impression, the service life of the rope will increase in most cases.

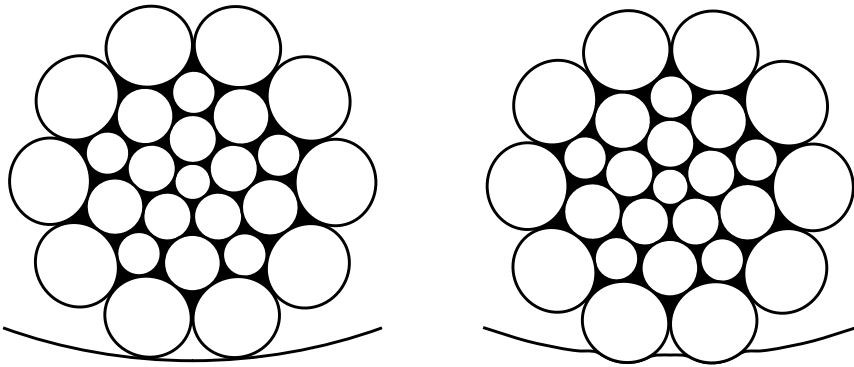
Also the use of elastic sheave materials, which are supposed to reduce the pressures in the point of contact by improving the bearing surface (Fig. 3), does not always show the desired effect. If the geometrical conditions are given, the wire rope will dig into a plastic sheave as quickly as into a steel sheave.

Figure 3: Contact conditions on steel (left) and on plastic sheaves (right)

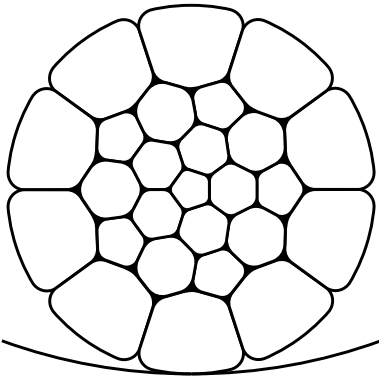
A very effective means against the formation of impressions in sheaves is the use of wire ropes with compacted outer strands. The outer wires of a compacted strand (Fig. 4) have been designed to fit the surface of the grooves much better than those of conventional outer strands (Fig. 5). By using ropes with compacted outer strands, the bearing surfaces are increased considerably and consequently the pressures and the material abrasion are reduced accordingly.

Figure 4: Compacted strand

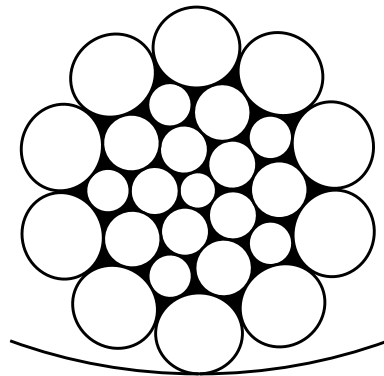
Figure 5: Conventional strand

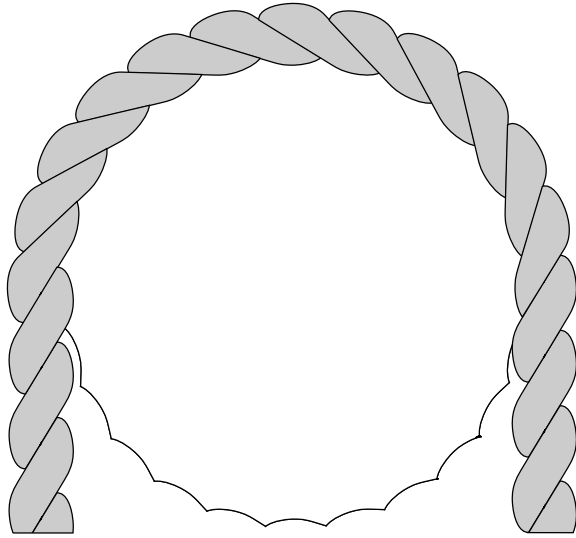
Figure 6: Good contact conditions for the old rope

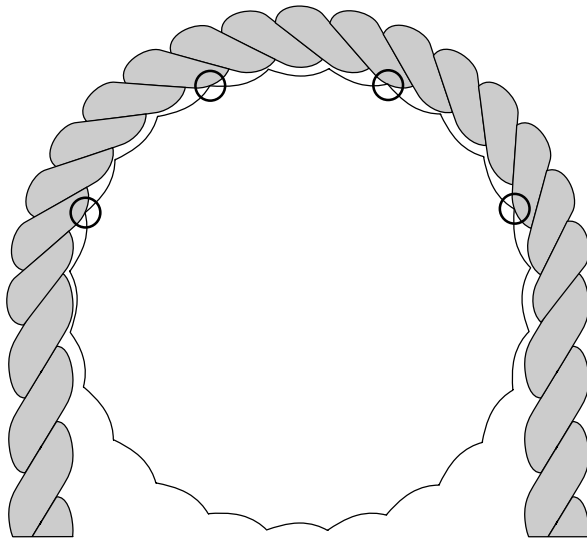
Figure 7: Very bad contact conditions for the new rope

If the rope that has caused the impression is discarded, the replacement rope, however, will find very unfavourable conditions on the imprinted sheave, as its diameter and its lay length will not match the profile on the sheave (Fig. 7). Its very few points of contact will be subjected to very high pressures which will reduce its service life tremendously.

Additionally, the rope will try to adopt the lay length of the profile in the groove and will therefore tend to structural damage, e. g. cork screw formation. Therefore, if severe impressions are found, the sheaves should be replaced or machined when a new rope is installed.
